## **PHILOMATH SCHOOL DISTRICT 17J**

### **EDUCATIONAL FACILITY ASSESSMENT & LONG-RANGE FACILITY PLAN**

**June 29, 2020**

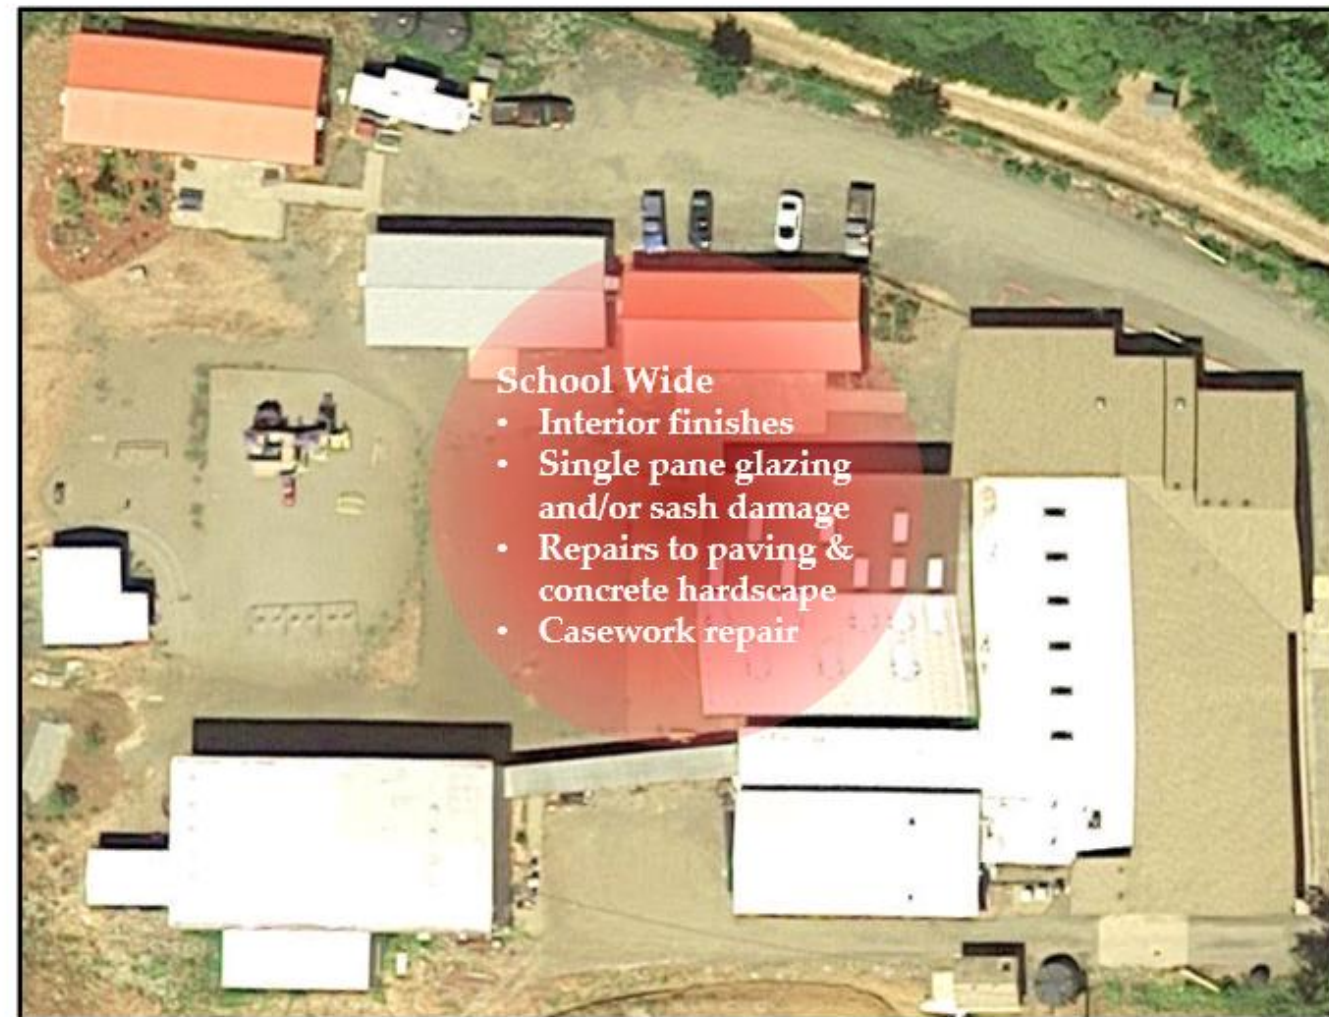
- \$32,055 – Numerous portions of ceiling, wall, and floor interior finishes, including wall board, carpet, concrete and others, have been assessed as various levels of deficiency
- \$16,720 - 58% of aluminum windows have single pane glazing or the sash is damaged
- \$15,132 – Minor and major deficiencies noted on pavement and concrete paving
- \$5,436 – 20% of casework (counters, cabinets, shelving) were determined to have moderate damage

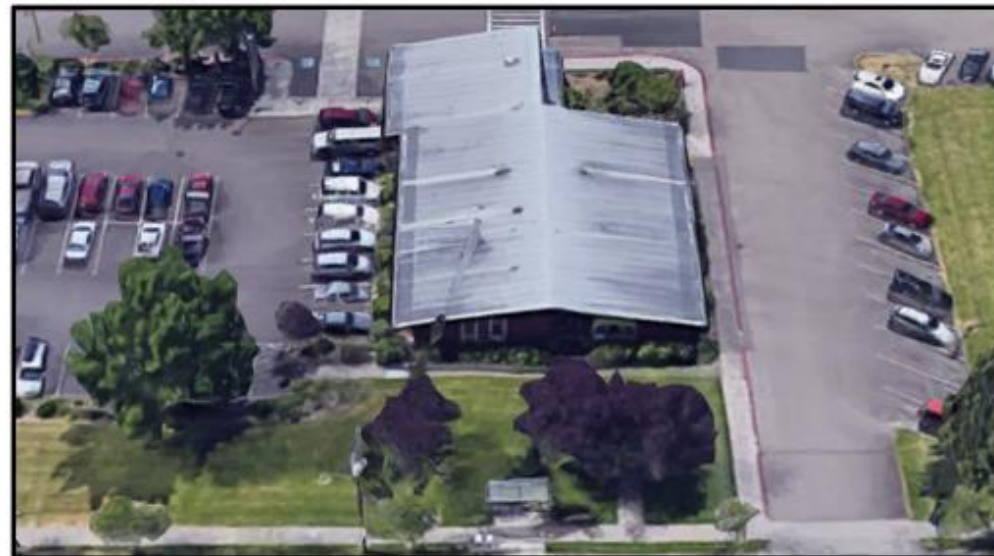
- \$50,160 - 100% of aluminum windows have single pane glazing or the sash is damaged
- \$6,840 – 15% of concrete pedestrian paving has sections that are broken with differential settlement requiring the removal of the effected panels and replacement

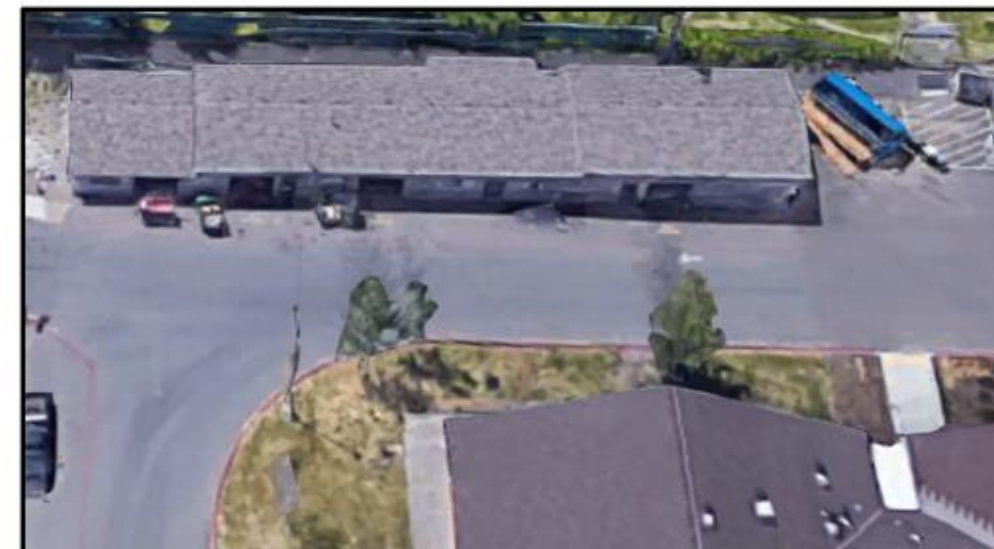
## Maint. & Tech. Building

- \$13,200 - 100% of aluminum windows have single pane glazing or the sash is damaged
- \$6,600 - 20% of exterior walls have damaged requiring patch and repair prior to re-painting.

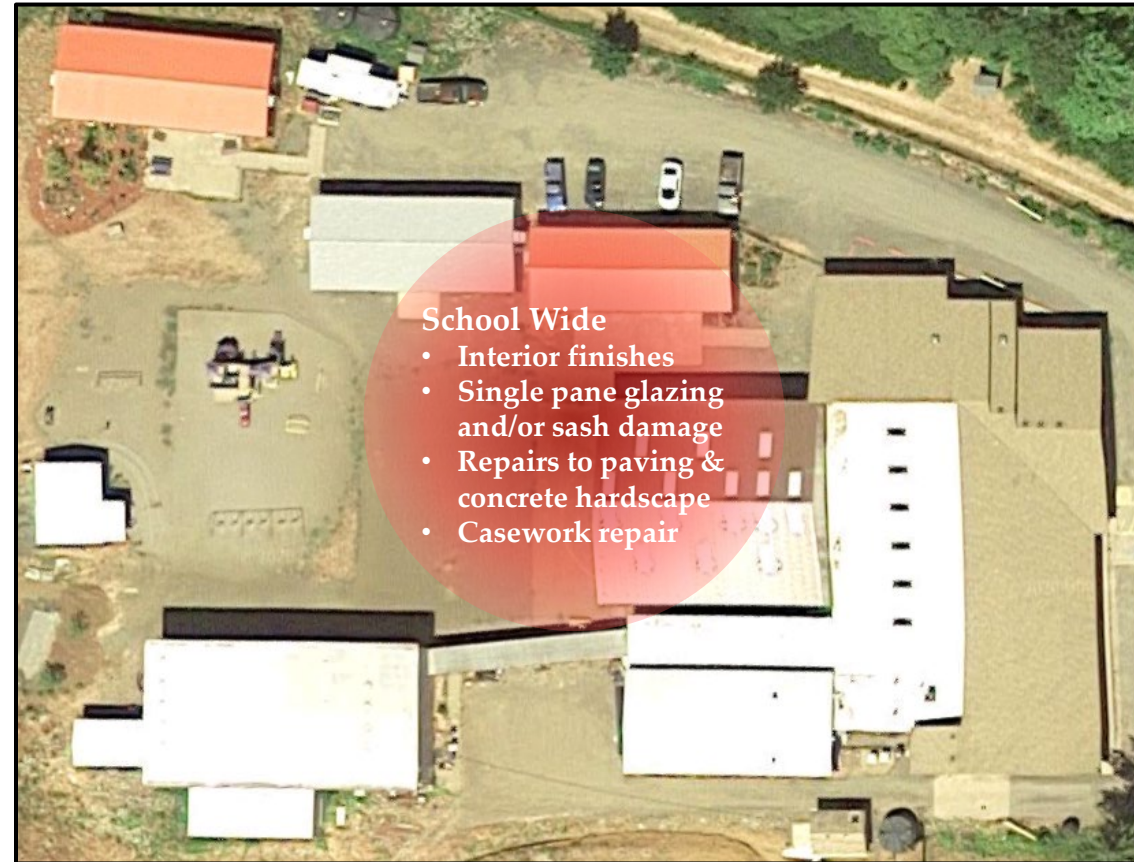
- **\$32,055** – Numerous portions of ceiling, wall, and floor interior finishes, including wall board, carpet, concrete and others, have been assessed as various levels of deficiency
- **\$16,720** - 58% of aluminum windows have single pane glazing or the sash is damaged
- **\$15,132** – Minor and major deficiencies noted on pavement and concrete paving
- **\$5,436** – 20% of casework (counters, cabinets, shelving) were determined to have moderate damage

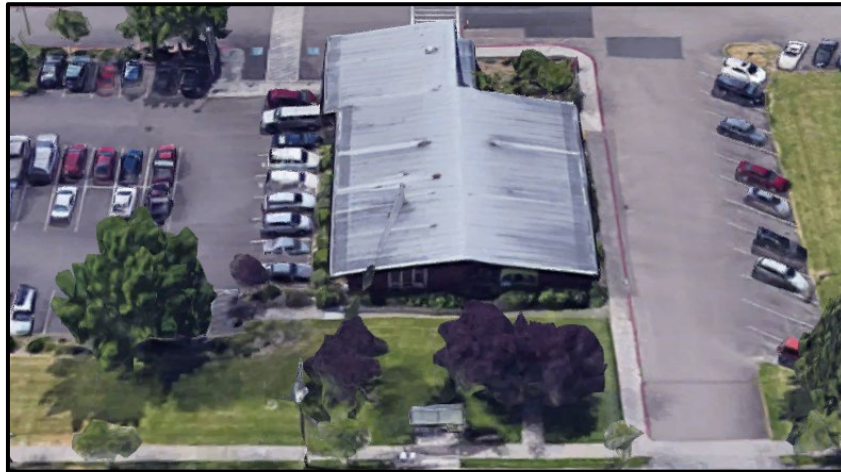
- \$50,160 - 100% of aluminum windows have single pane glazing or the sash is damaged
- \$6,840 - 15% of concrete pedestrian paving has sections that are broken with differential settlement requiring the removal of the effected panels and replacement

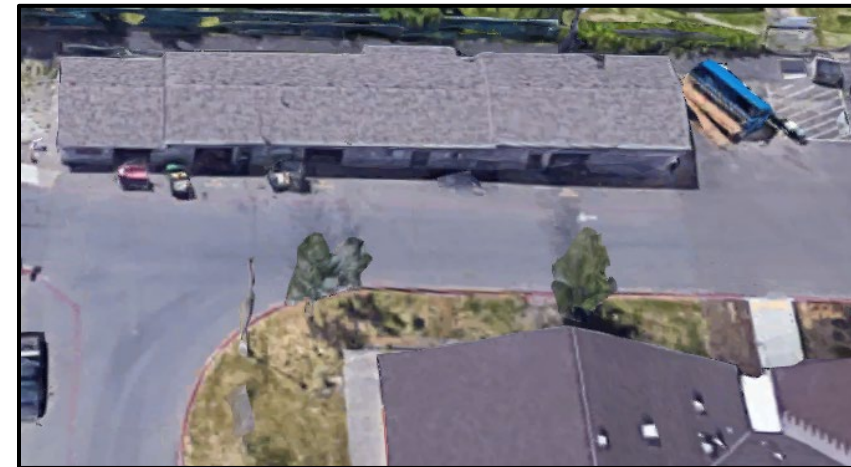
## Maint. & Tech. Building

- \$13,200 - 100% of aluminum windows have single pane glazing or the sash is damaged
- \$6,600 - 20% of exterior walls have damaged requiring patch and repair prior to re-painting.
